ROCKET, AT, 2.37", M6, ROCKET, PRACTICE, AT, 2.36", M6,
AND LAUNCHER, ROCKET, AT, M1.

October 15, 1942.

Subject: Report of Test of:
Rocket, AT, 2.36", M6,
Rocket, Practice, AT, 2.36", M7,
Launcher, Rocket, AT, M1.

REPORT OF TEST OF:
ROCKET, AT, 2.37", M6
ROCKET, PRACTICE, AT, 2.36", M7
LAUNCHER, ROCKET, AT, M1

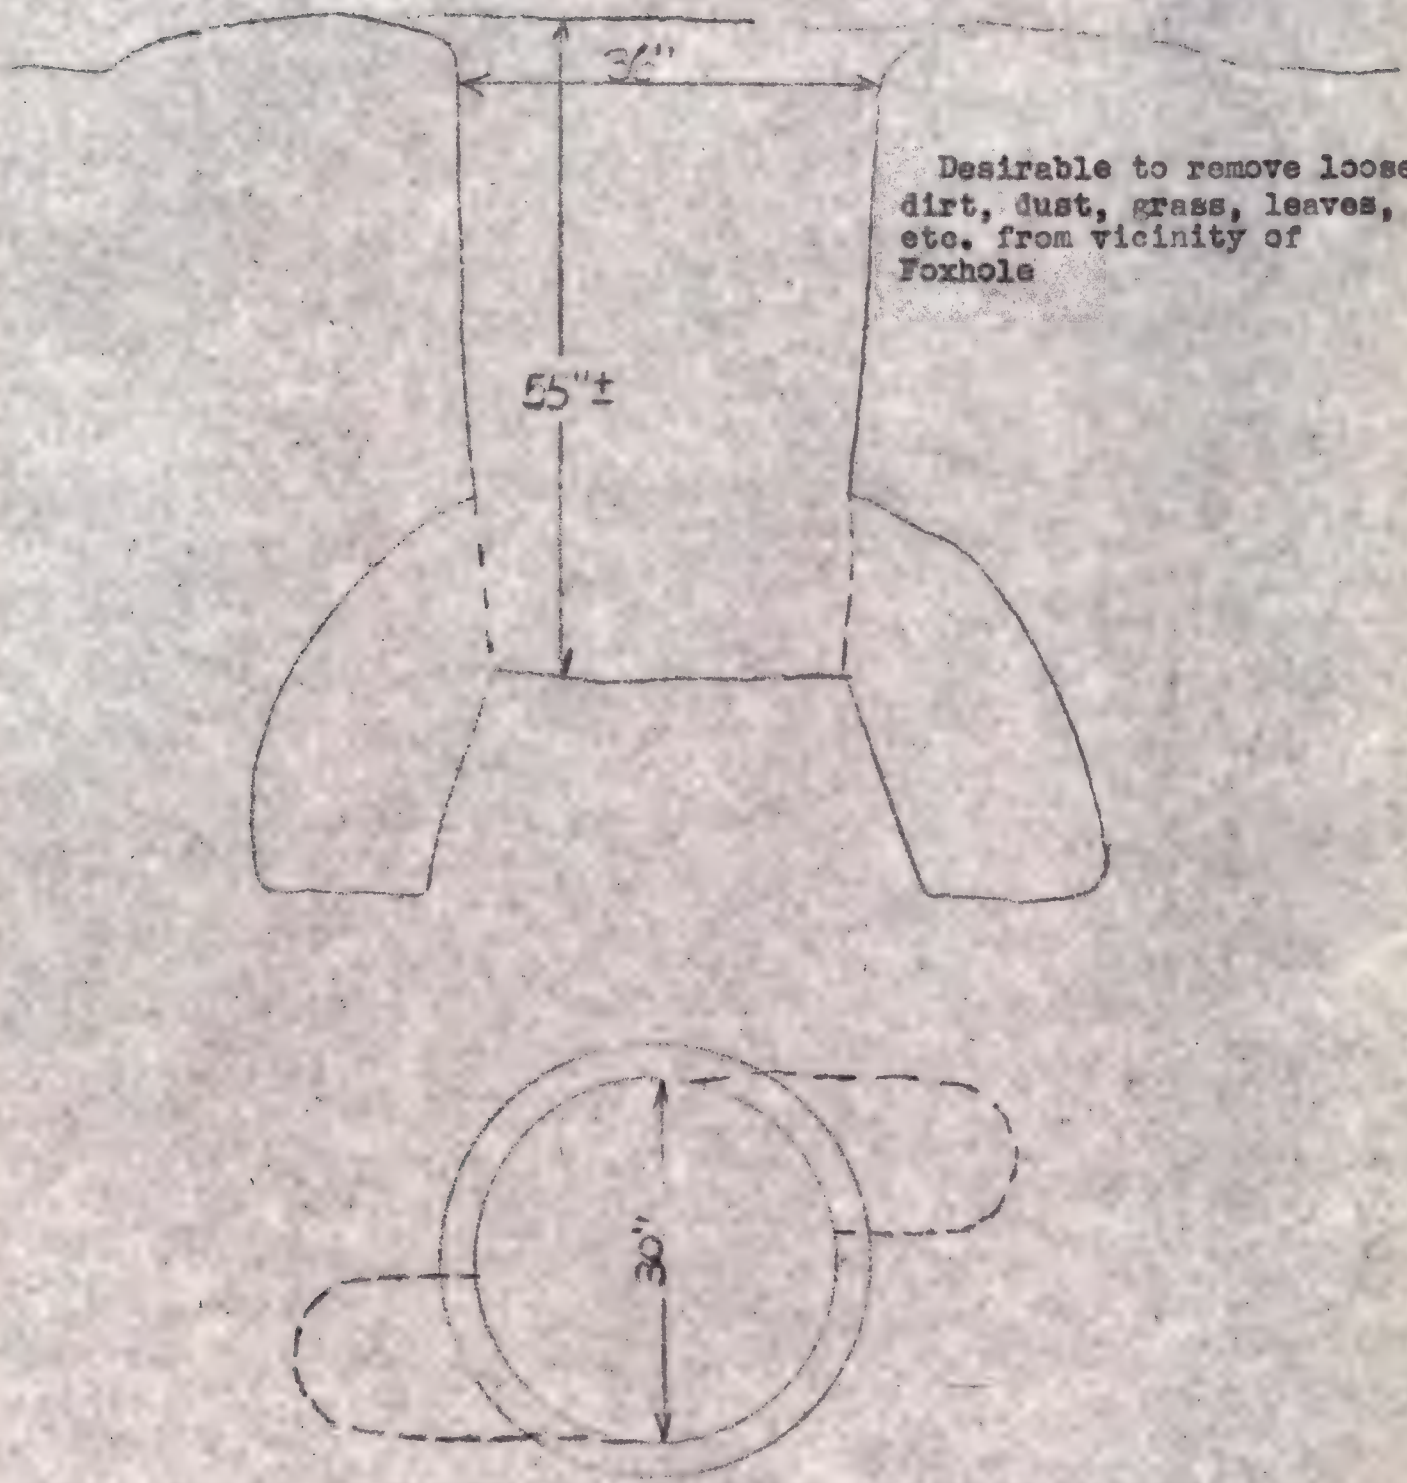
22-A

(d) It is desirable to remove all loose dirt from the vicinity of the foxhole to reduce the dust cloud

Sketch of Satisfactory Foxhole
